COURSE SUPERINTENDENT'S REPORT

15th DEC 2020 – 19th JAN 2021

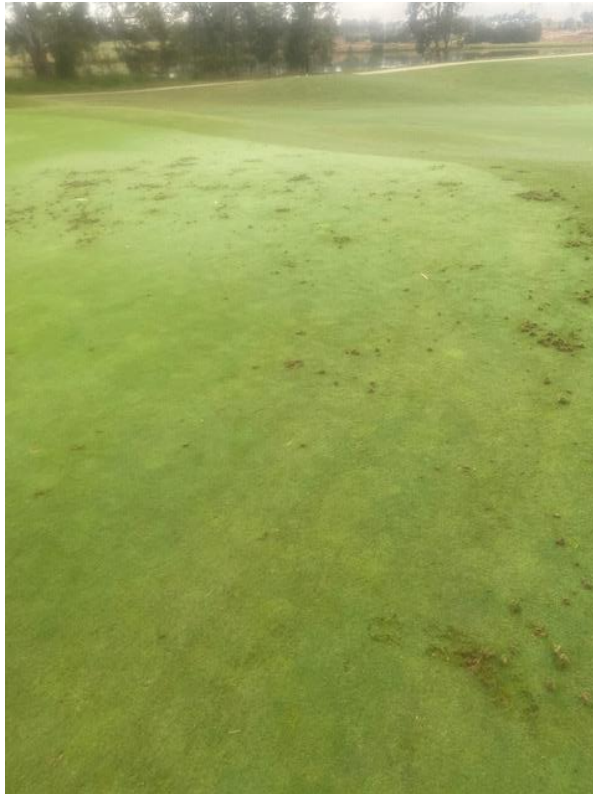
The current 12th hole is taking a beating from Corella's and plugging has resulted.

THE DAMAGE CAUSED DAILY BY THE CORELLAS

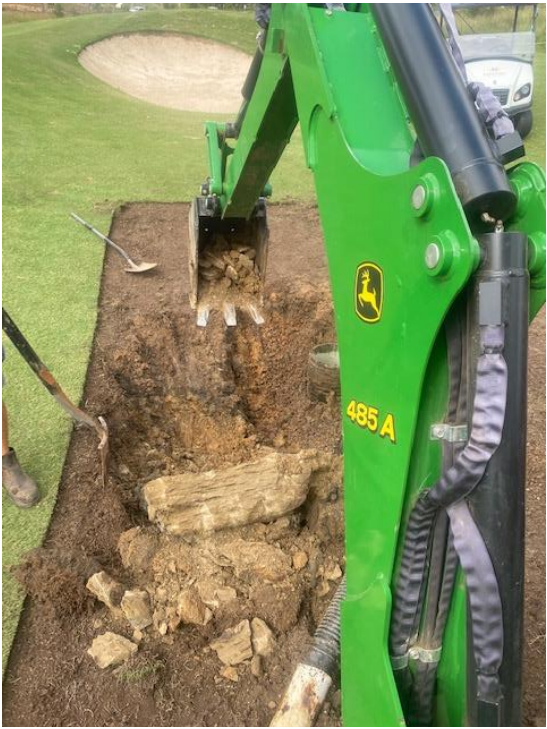
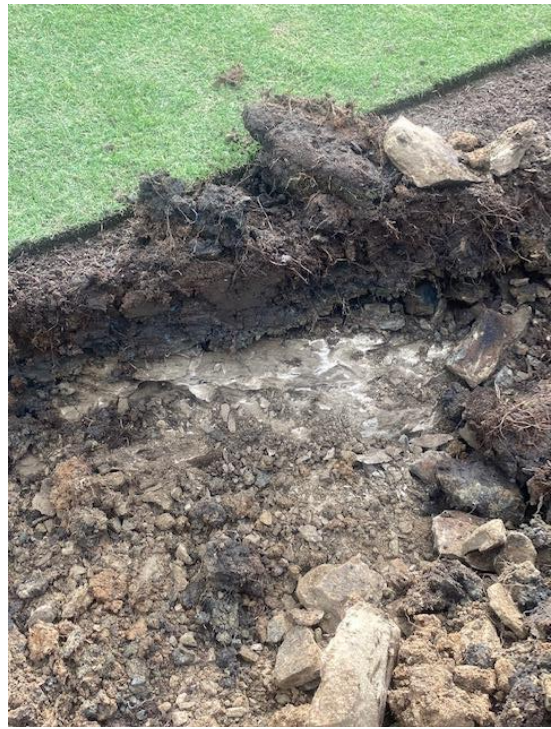
The area on the 8th RHS of the green (old 7th) was drained as best we could. As you can see in the pictures, the reasons for areas like this to hold water are from the shale shelf that the turf sits on. We managed to dig out a well around the pit adding much more gravel, and we then added some fresh growing medium and removed the stale thatch layer that the turf has been placed over. We continued an 8 m drain all the way up the gully to help with drainage in that area.

THE SHALE ROCK SHELF THAT SITS ALL THROUGH THE SURROUNDS

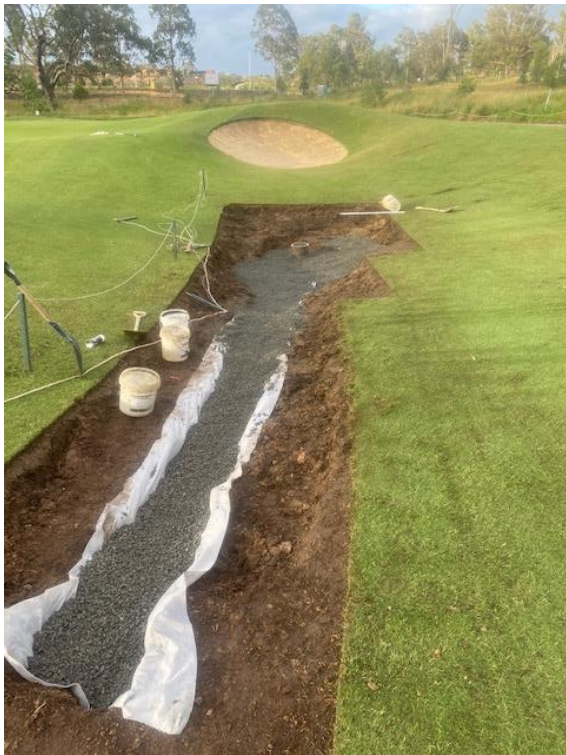
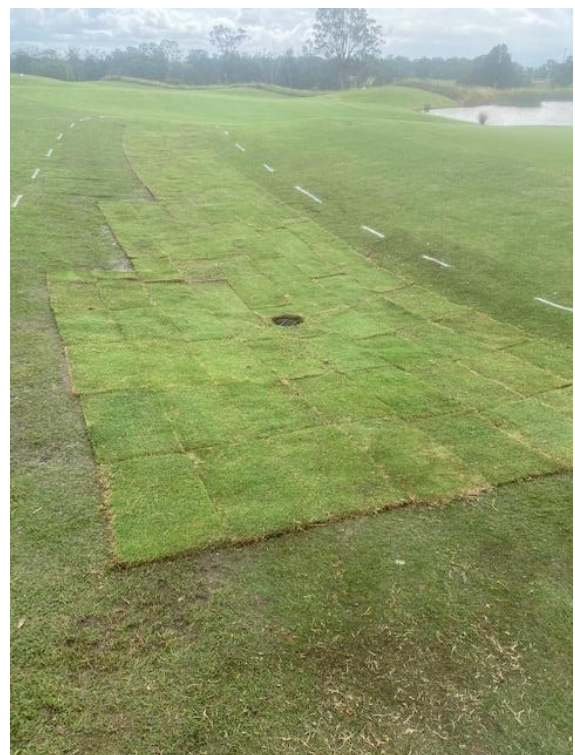
FINISHED PRODUCT AFTER GRAVEL AND SAND IS PLACED IN TRENCH

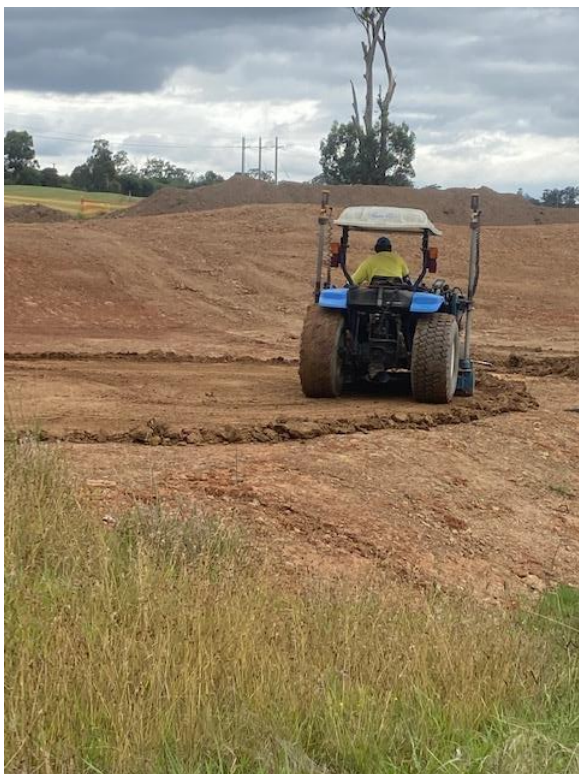
Laser levelling of tee platforms
