COURSE SUPERINTENDENT'S REPORT

7th DECEMBER 2021 – 18th January 2022

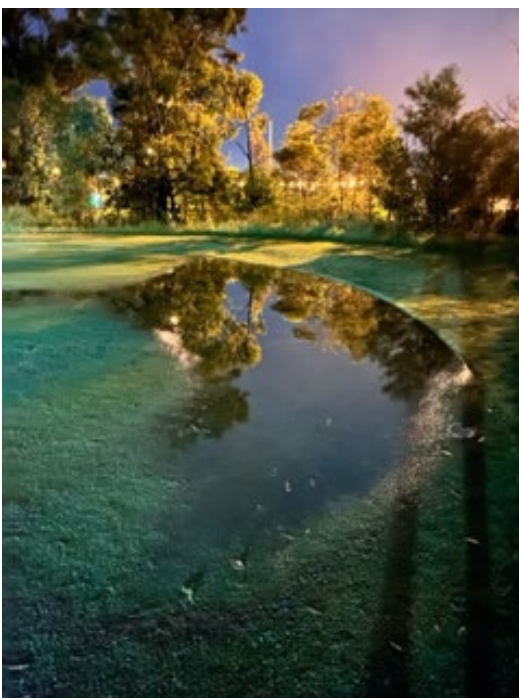
Tees are cut twice weekly and showing good growth. Tees on 13/14/15/16/17 have been wet. It's not uncommon as these tees do not have drainage in them. Although the sub base is graded with a fall, the soil is saturated at this time and hence that it takes them a little longer to dry.

3rd back tee on a Saturday morning at 4am. Normally a good tee that drains well, but just couldn't handle any more rain. This tee was playable by the morning tee off.

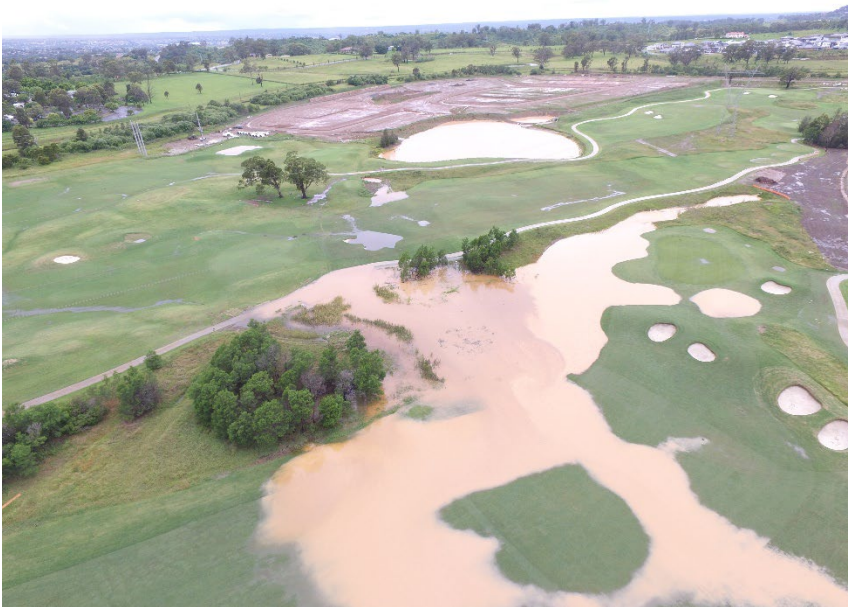
This is a view of the 16th green which is dry but surrounded by water and fairway during a rain event of at least 3 inches of rain in a short period of time. Photo taken at 3pm, and water gone by 5am the next morning.

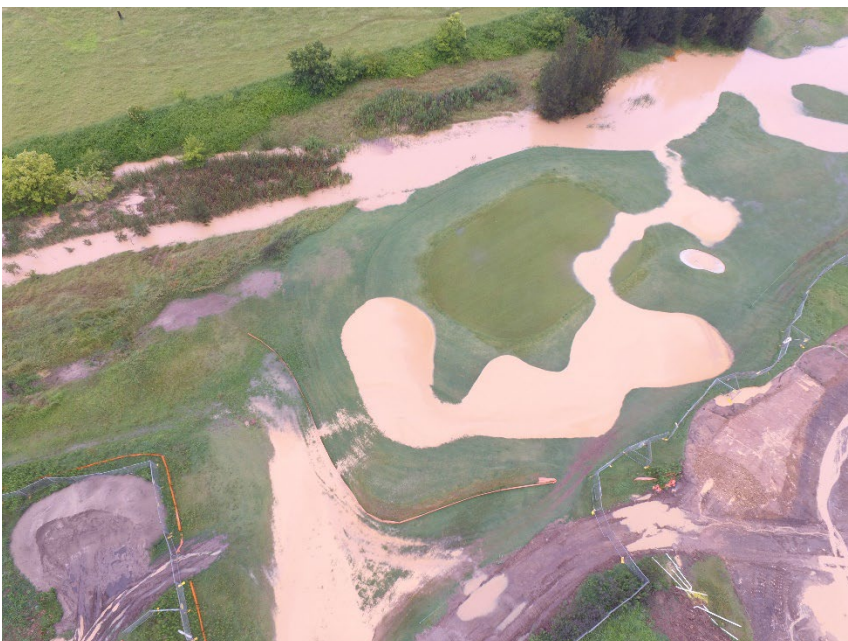
This is a view of the 9th green which has slightly gone under during a rain event of at least 3 inches of rain in a short period of time. Photo taken at 3pm, and water gone by 5am the next morning. This area will improve through the development stages.

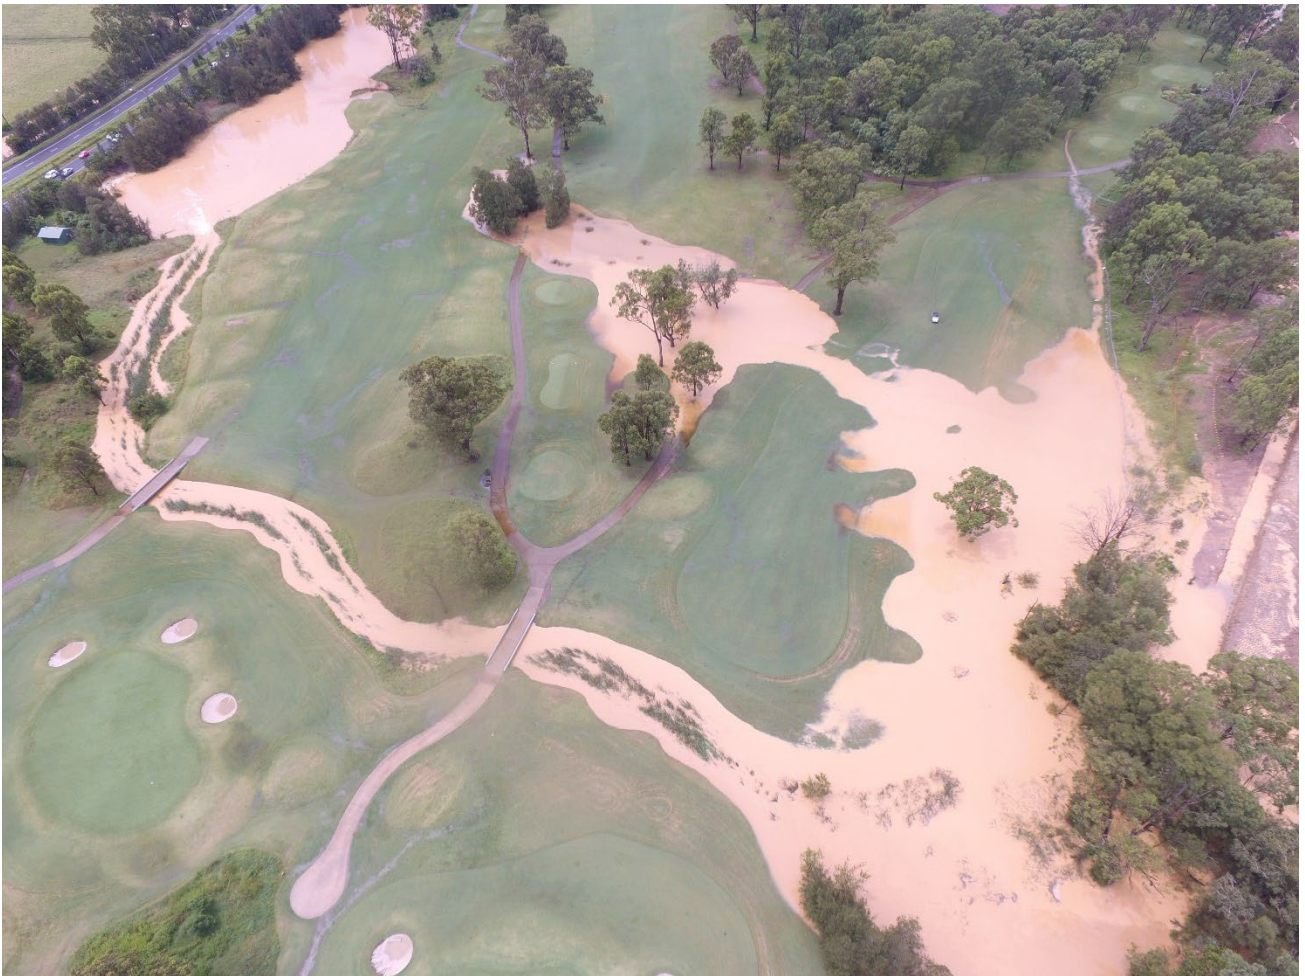
This is the 1st fairway obviously not coping with the high rainfall event of 3 inches over a short period of time. Solutions to this will be worked through in the coming months.
