LAKESSIDE GOLF CLUB CAMDEN

COURSE UPDATE 9.3.22 – FLOODING AND RAIN

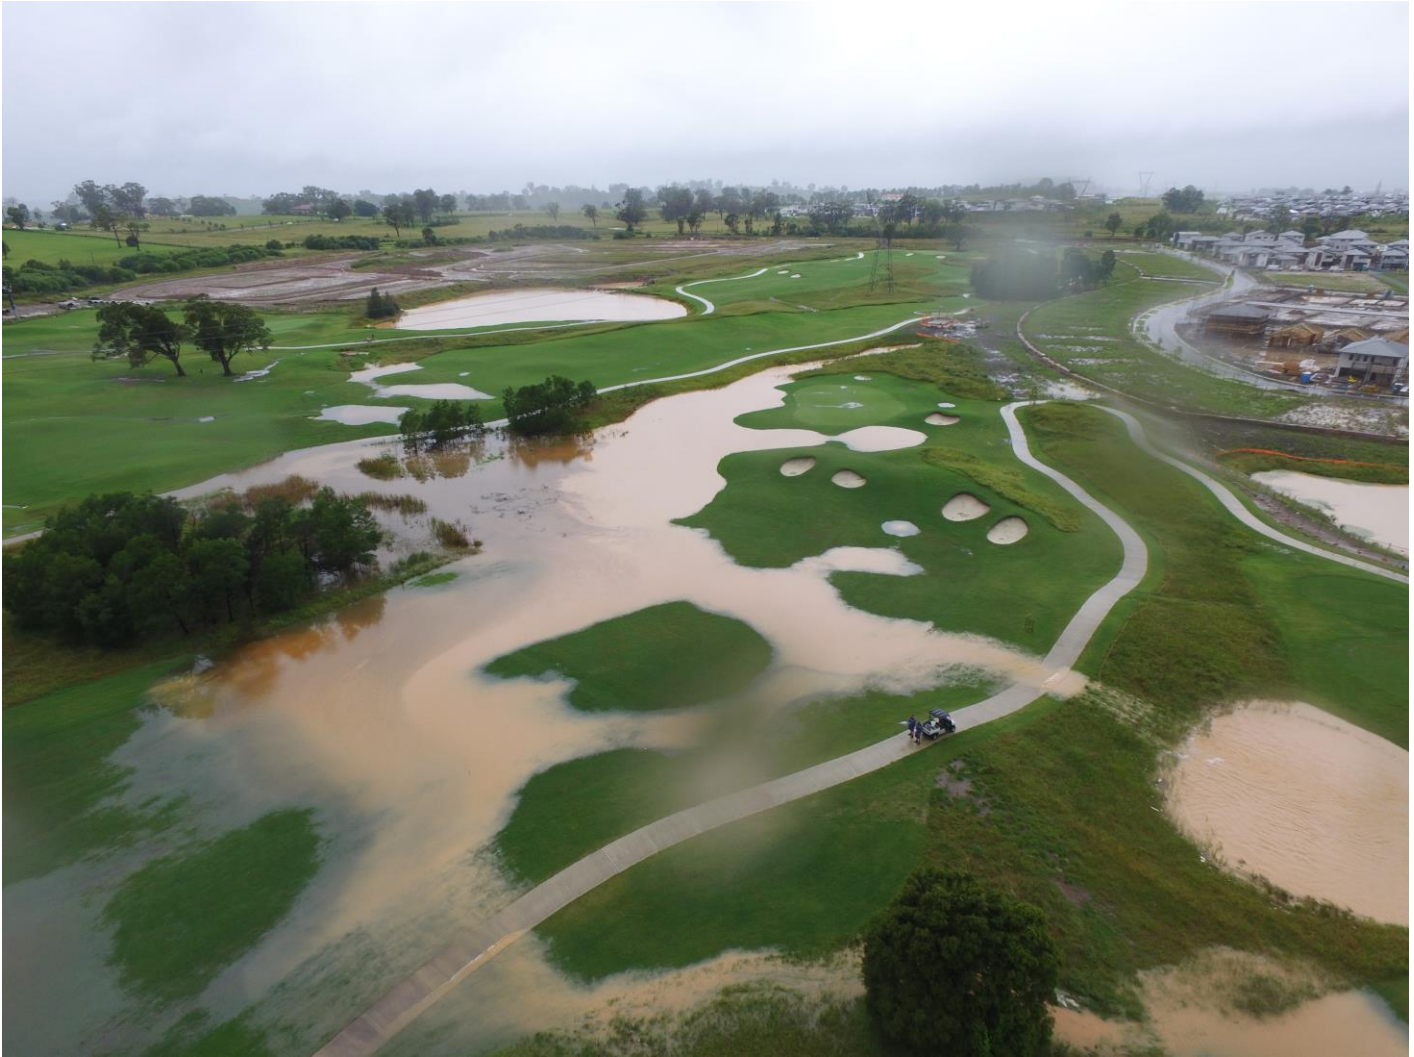
16th fairway

We haven't got through with no damage but our course has come through pretty well considering. Low lying areas that have held puddles for 2 weeks will no doubt show signs of disease and damaged turf. These we are anticipating will bounce back with favorable weather in the coming week.

The heights on all surfaces of the course except greens will be raised to minimize damage. Some grass we could not cut for 2 weeks. Scalping will occur and turf will look yellow in parts for some time to come. We will endeavor to get the heights back down to a normal over a period of time.

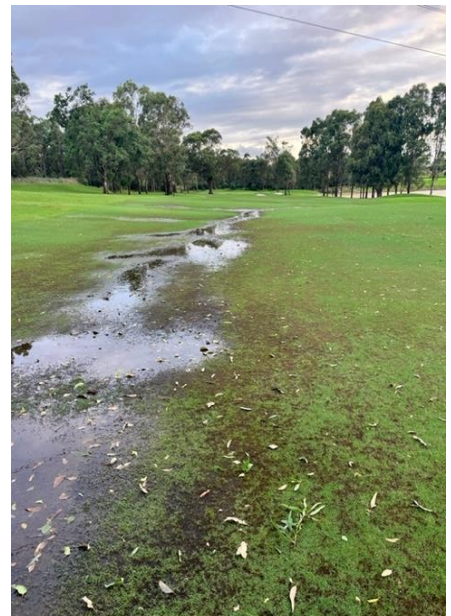
Black Helminthosporium (Helmo) is a common black leaf spot disease which is actually caused by Drechslera, Curvulari, Bipolaris and Exserohilum species of fungi. The disease cycle is generally short, as it requires extended periods of leaf wetness to develop and survive. All fairways have this disease through and we are confident this will disappear over time and better growing conditions. Tees and greens thankfully were cut in between the worst days, and don't show signs of this disease to the same extent.

11th fairway damage from constant water

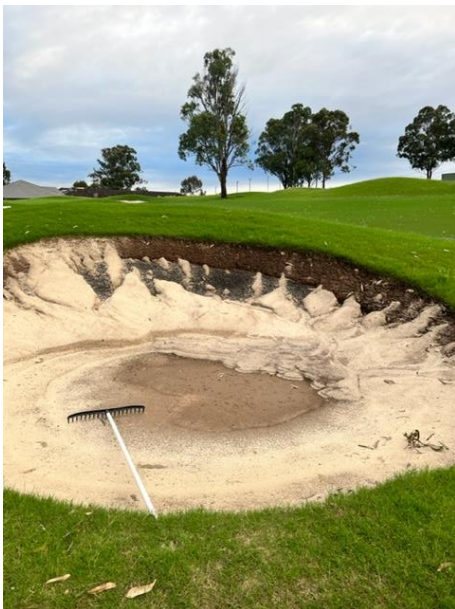
18th bunkers

Bunkers have silt in some of them from surrounding areas, with some having little sand in them. The good news is the newly constructed holes have very little damage at all and will be back in play straight away. We will need to pump, de silt, fix matting and liners in some and add more sand in many of them and this will take time.

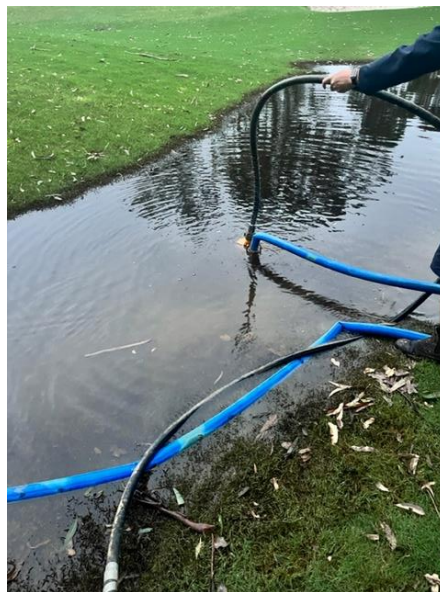
10th hole

Silt and mud from water coming onto the course from external developments will be cleaned as much as possible and has already commenced with priority to the most important surfaces first. This will be a time consuming effort and thankfully we don't have many areas at all that require this.

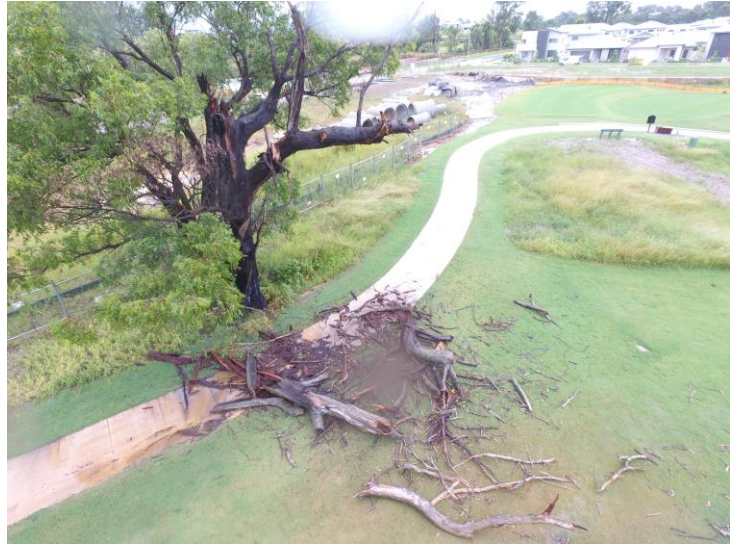
Tree branches are down and the place has leaves and bark all over it. The vac will go out as soon as it can get out without causing too much damage, and all is easy enough to clean up.

Rear 13th green tree branch down

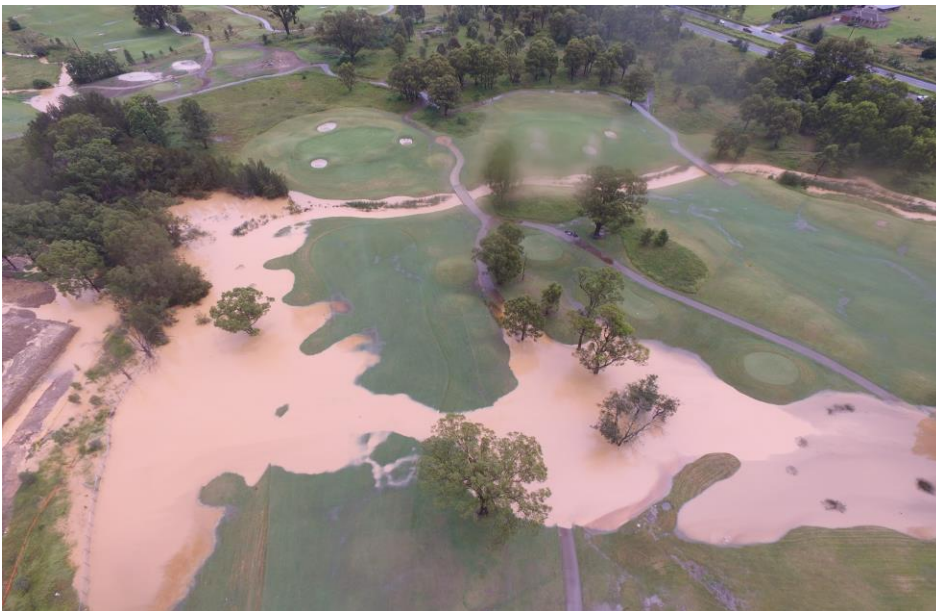
1st fairway and 2nd dams

Our aim is simple. Get the course playable as soon as possible. Mowing has commenced with greens. Tees, fairways and roughs need much longer drying as limited drainage. Will it still be wet under foot for re-opening, yes it will. It would take at least 5-7 days of sunshine, wind and high temperatures to be able to say we can get carts back out. At this stage with no rain we are looking at Tuesday 15th for carts. We are hoping to get walkers out there as soon as safe to do so and that could possibly be Friday or Saturday this week weather depending. Staff are slipping around the place today just trying to get limited access, and it will take some time to get those areas good under foot.
